SB, Fuel Hose Contact with Rear Tire, Poulan Pro Zero Turn Mowers Equipped with Briggs & Stratton Twin Cylinder Engines, P54ZX, 2017-12

Service Bulletin B170066C-14

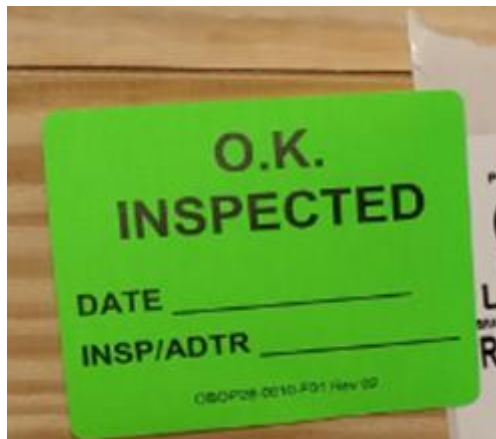
Units inspected at the warehouse are identified with a green label "OK Inspected". No action is required if the crate has a Green Label affixed to the crate tag.

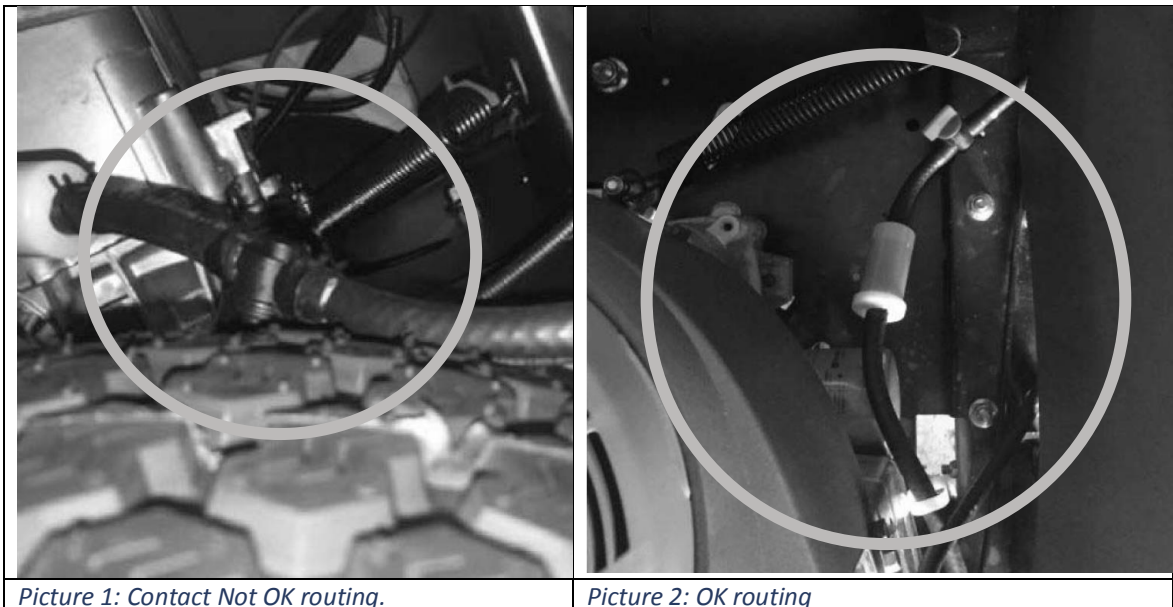
Routing of the fuel hose can potentially result in contact between the fuel hose and the right rear tire. Contact may result in rubbing and abrasion of the fuel hose, which creates the potential for leakage of fuel.

- Step 1.** Using a flashlight, check the position of the fuel hose. The picture on the left shows incorrect routing where fuel hose contacts the Right Rear Tire (Picture 1). The picture on the right (Picture 2) shows the correct routing where fuel hose is positioned on the engine plate away from the tire.

- Step 2.** Check fuel hose for damage. If any damage is observed, replace fuel hose assembly.

Note: If fuel hose has no damage and routing is correct, service is not required.
